Central Mines Rescue Station

Rescue action carried out in extremely difficult mining conditions, with coexistence of fall of roof, methane and water hazard.

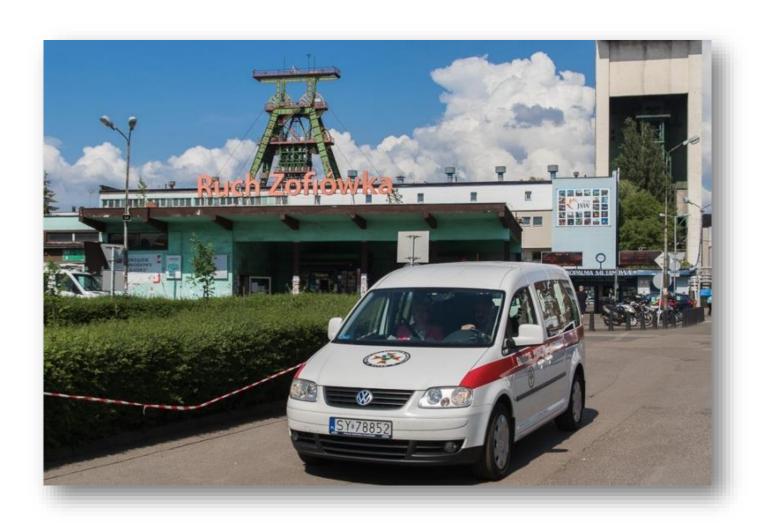
The rescue operation was carried out in two stages:

- ✓ First stage searching for missing employees
- ✓ Second stage closing the area (insulation)

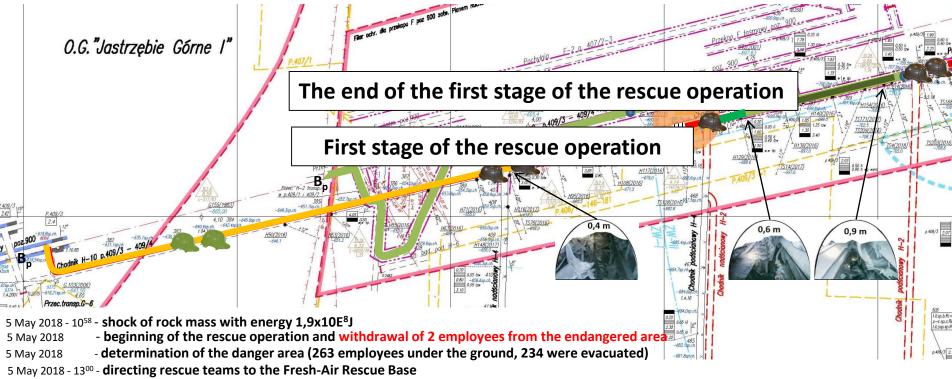
- 5 May 2018 1330 penetration of the excavation, rescue team found two missing employees at 1614 (at meterage of approximately 150 m)
- 5 May 2018 21¹⁰ rescue team found the third missing worker (10 m west of the H-4 tailgate)

- 6 May 2018 10⁵⁷ rescue team found the fourth miner (5 m east of the H-4 tailgate)
- 6 May 2018 penetration of the excavation and use of the GLON-GLOP location system

- 7 May 2018 setting up of sub-Fresh-Air Rescue Base 1 and 2
- 7 May 2018 the rescue teams penetrated the H-10 excavation and had a try to localize missing miners by using the GLON-GLOP system

- 8 May 2018 searching for people by using rescue sniffer dog
- 8 May 2018 installation of power systems for 4 pomp stations and overflow tanks
- 8 May 2018 consultations to determine the ability of use underwater penetration by diving techniques and underwater robot

- 8 May 2018 drilling a technical borehole with a diameter of 80mm from the F cross heading, level 900
- 12 May 2018 2045 the fifth missing worker was found (after pomping/lowering the water surface by about 1,5 m)

- 13 May 2018 $\,3^{00}\,$ the sixth missing employee was found
- 15 May 2018 23⁵³ the seventh missing miner was found

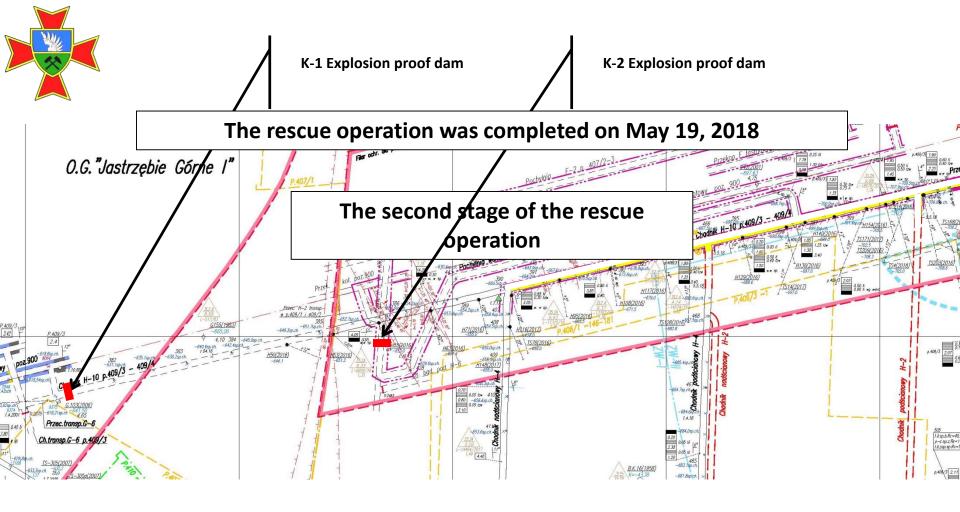
Works related to the building of K-1 explosion-proof dam in the H-10 and K-2 excavation in the H-2 cross heading.

Building starts on 16/05/2018 and ends on 18/05/2018.

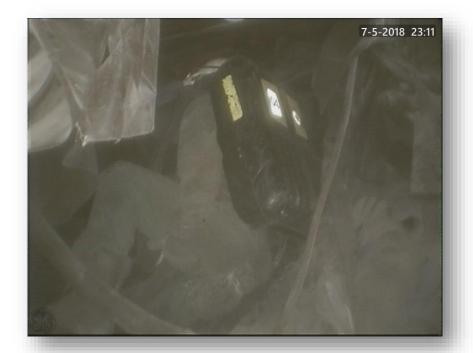
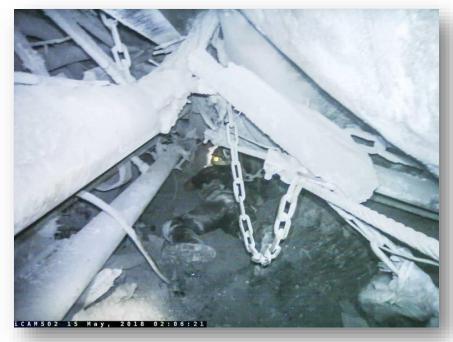
Difficulties during the operation:

- ✓ Concentration of gases at the explosion limit
- ✓ Unbreathable atmosphere
- ✓ Narrowed sections of excavations
- ✓ Shocks of rock mass
- ✓ Temperature (up to 30°C)

During the first stage of the rescue action a high risk was taken due to the search for missing employees.
